Pekon Hospital Bombing

An airstrike impacting a medical facility and IDP camp allegedly resulted in the injury of civilians

REPORT BY MYANMAR WITNESS, 27 April 2023

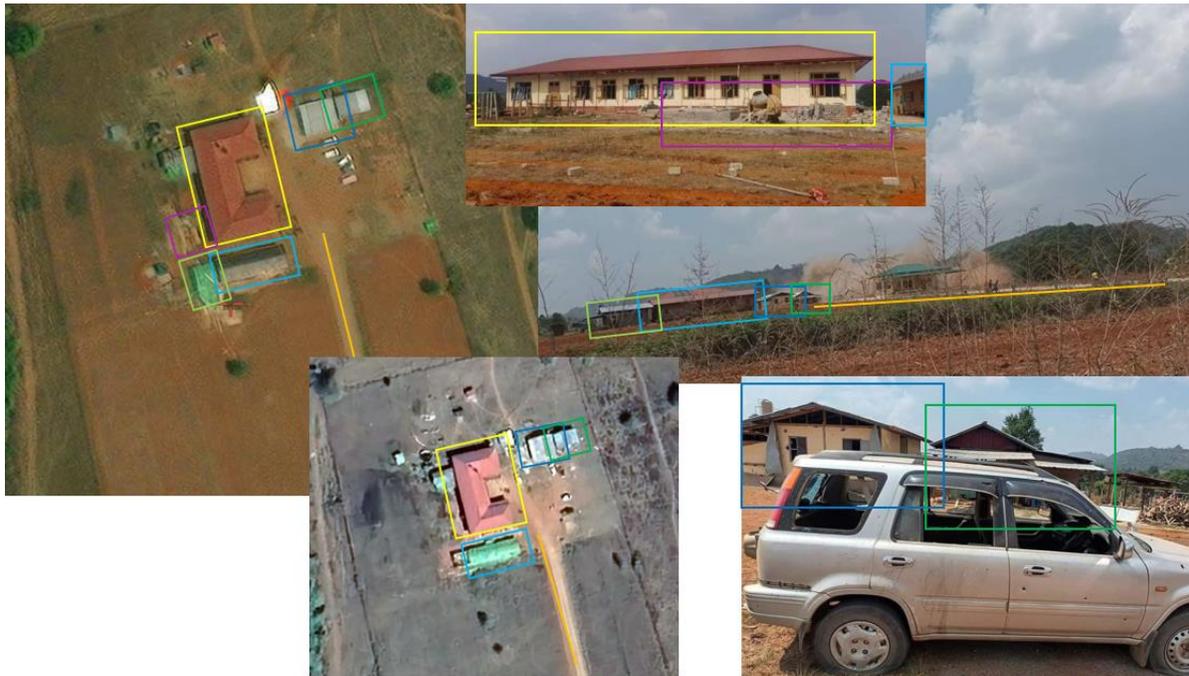
Figure 1: Geolocation by Myanmar Witness of a medical facility affected by an airstrike to 19.669828, 96.889449. (Source: [MeKong News](#)).

Myanmar Witness geolocated the area of the alleged airstrike and smoke in the footage uploaded by [MeKong News](#) and [Khit Thit Media](#) (Figures 1 and 2) to around 19.669828, 96.889449.

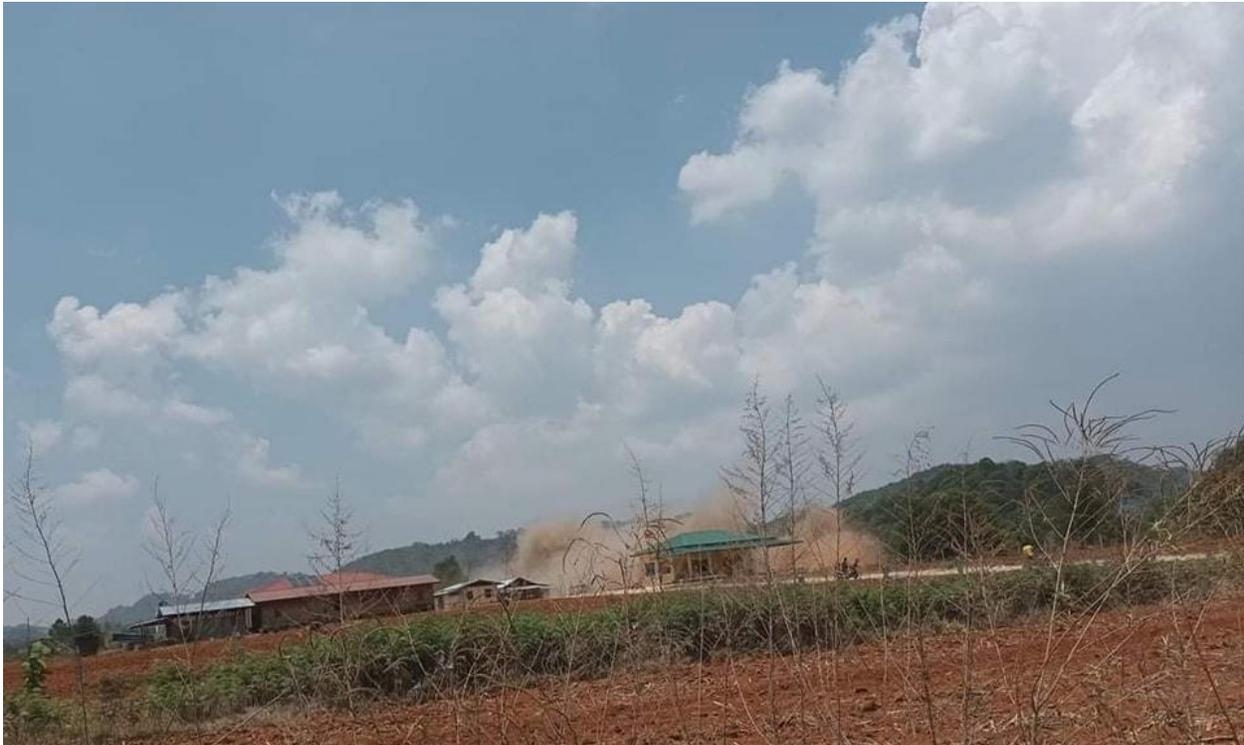
Figure 2: Smoke at the same medical facility, potentially from an airstrike. (Source: [Khit Thit Media](#)).

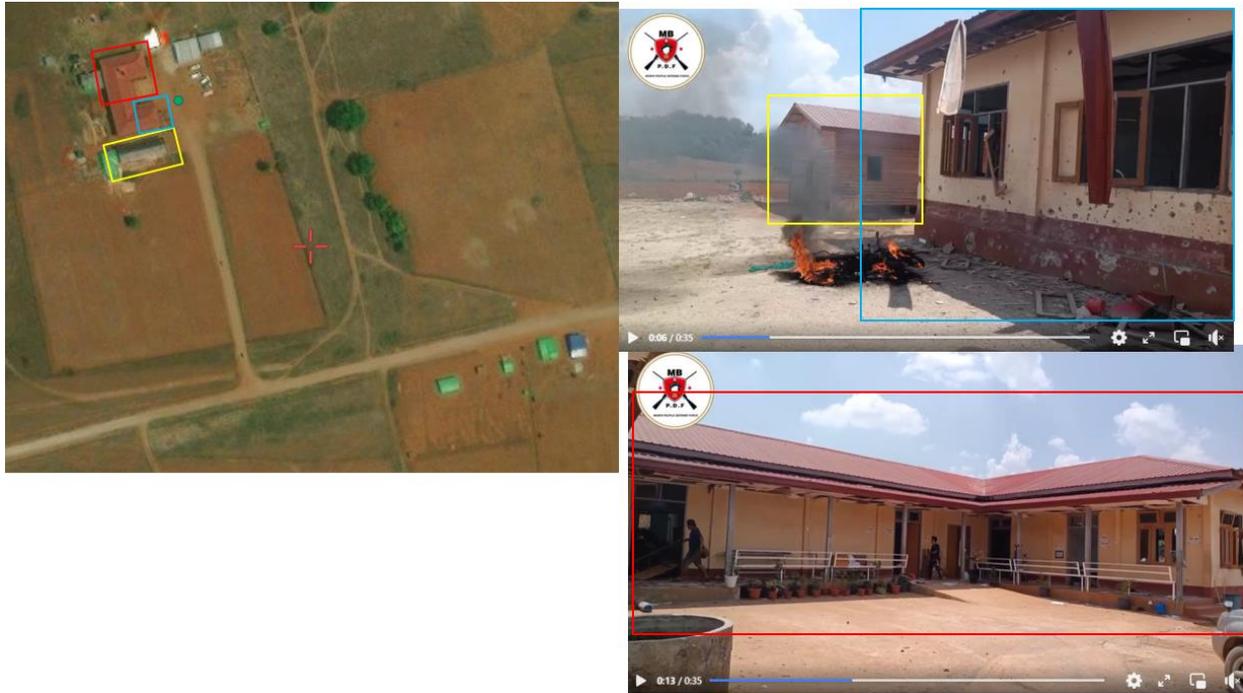
This structure shows signs of damage to the building consistent with an airstrike, including roof damage, a motorcycle on fire, damaged and overturned vehicles nearby, and heavy damage to the outer walls (Figures 3 and 4).

Figure 3: Images showing damage to the structure. (Source: [Moby People Defense Force](#)).

The damage shown in all of these images, particularly the heavy structural damage to the building, would be difficult to achieve using ground forces, giving support to the allegation that this was caused by an airstrike.

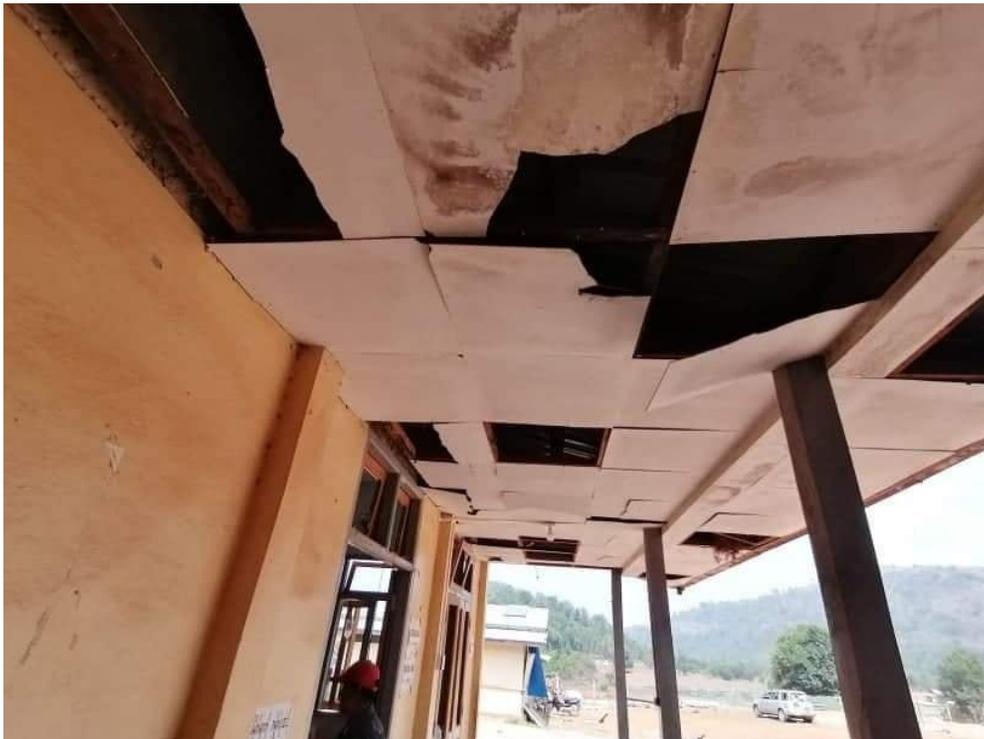
Figure 4: Images showing roof damage at the same site. (Source: [Khit Thit Media](#)).

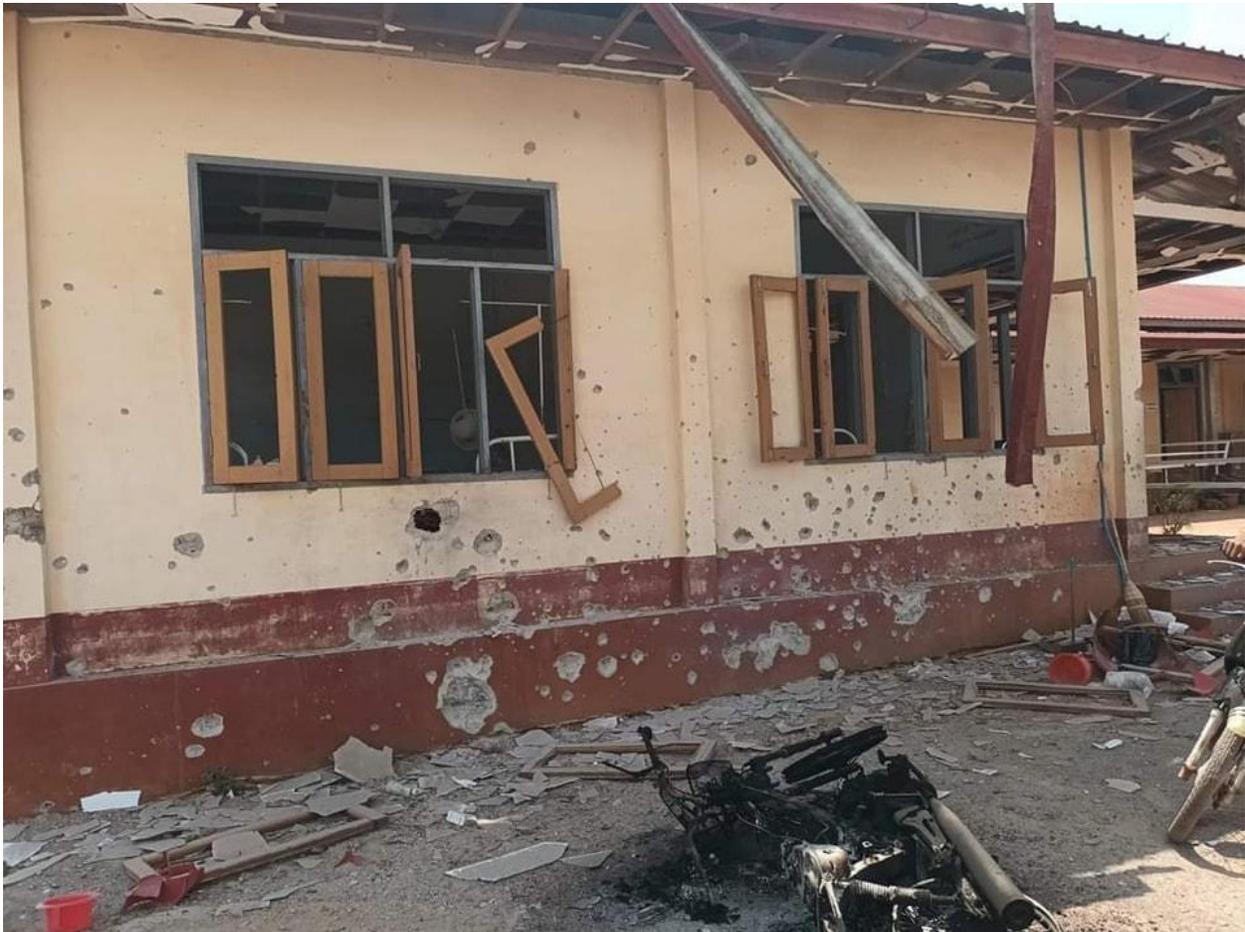
In one image geolocated by Myanmar Witness (Figure 5), featuring heavy external damage, it is possible to see through the windows of the building and identify what appear to be beds and medical equipment, supporting the claim that this building is a medical facility.

Figure 5: Image geolocated to the same area showing what appear to be beds and medical equipment inside the building. (Source: [Khit Thit Media](#)).

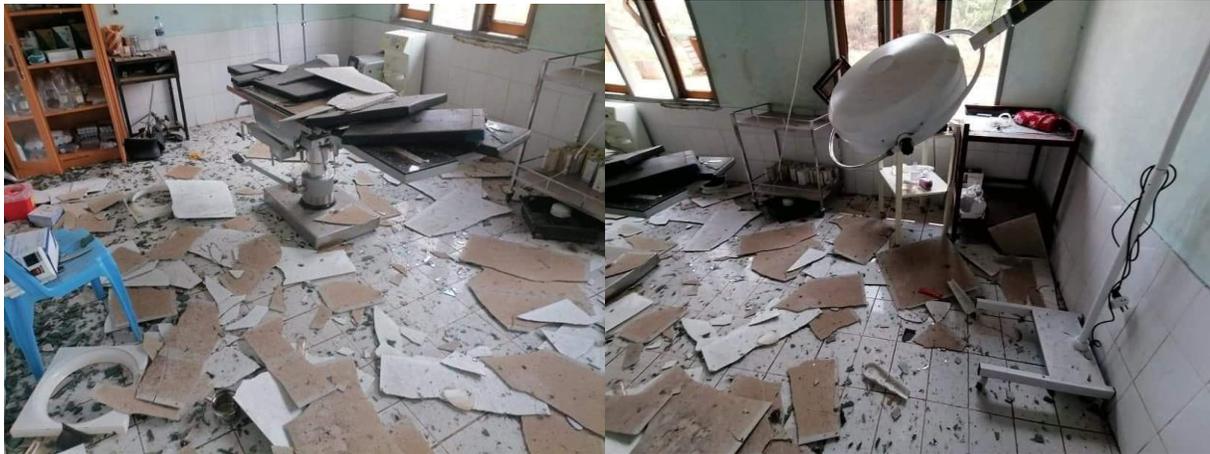
Additional images claimed to be from inside the building, although unable to be geolocated by Myanmar Witness, show damage to medical equipment and roofing material on the floor, consistent with an explosion (Figure 6).

Figure 6: Unconfirmed images of the inside of the building, showing significant damage to roofing and medical equipment. (Source: [Khit Thit Media](#)).

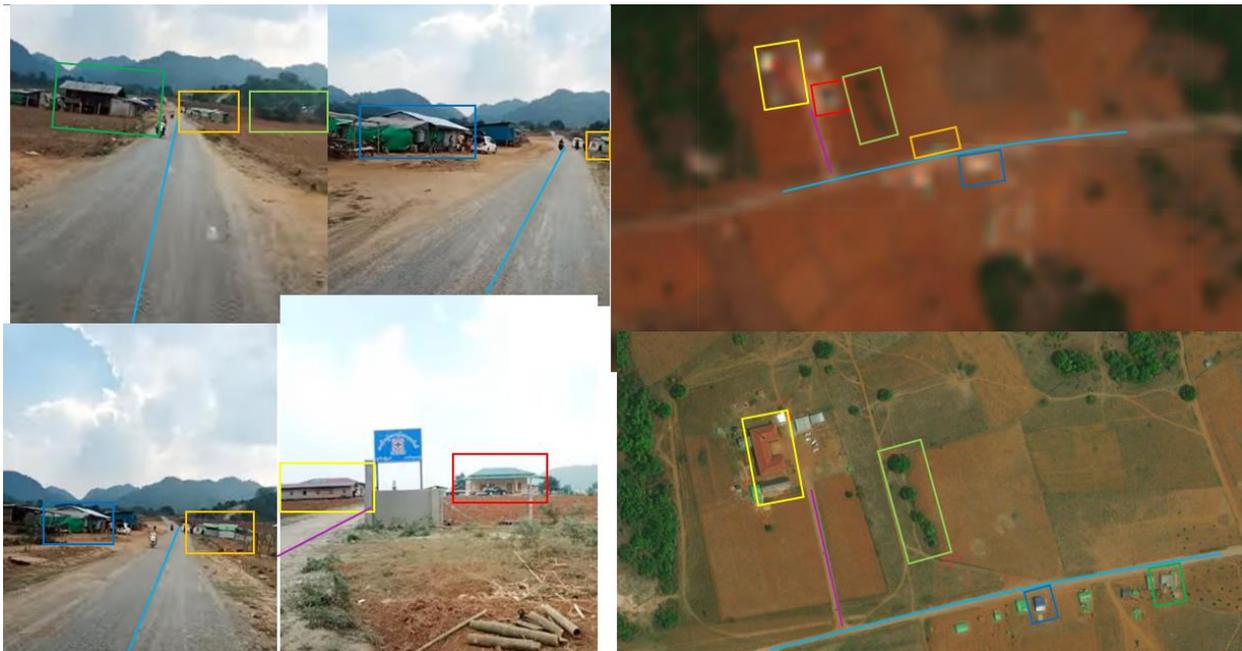
Myanmar Witness also geolocated footage from a source (who has not been identified here for privacy concerns) showing an IDP camp in Pekon, close to the medical facility, which is alleged to have been affected by the same airstrike (Figure 7).

Figure 7: Geolocation of imagery of the nearby IDP camp (left). Myanmar Witness used Sentinel-2 for more updated satellite imagery (top right, from 22 April 2023) as compared to the Google Earth imagery (bottom right), which had not been updated since an expansion of the camp.

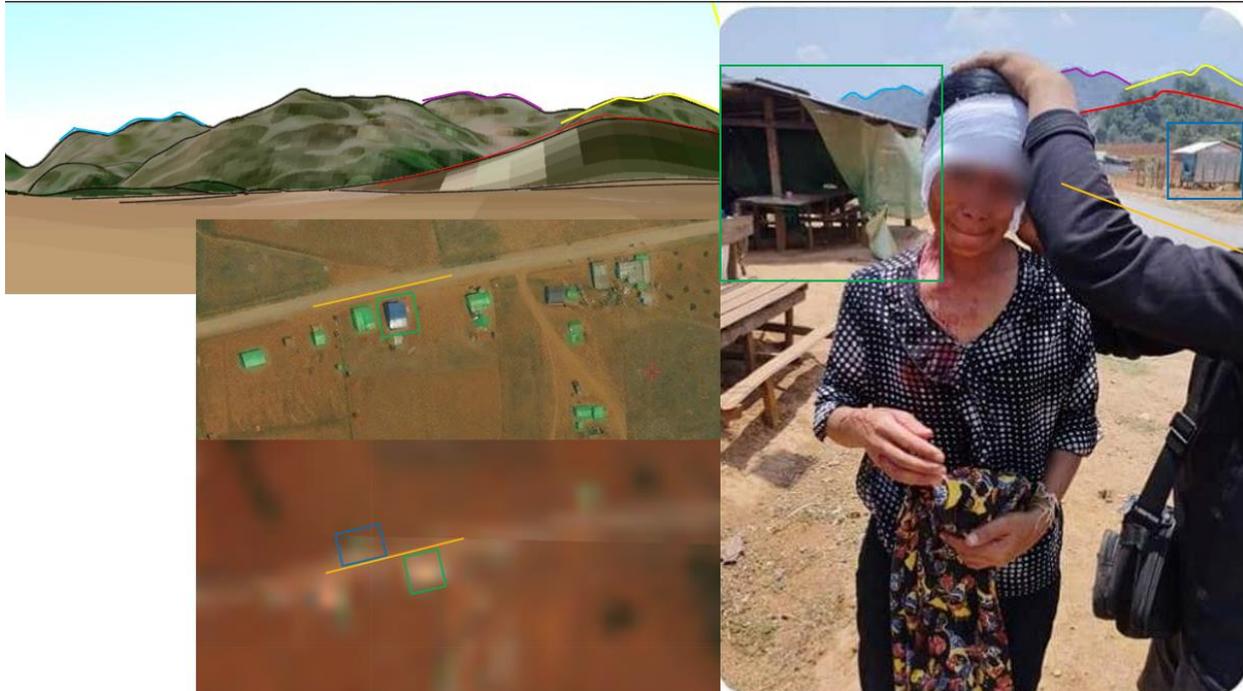
In footage uploaded by [Khit Thit Media](#), claimed to show the aftermath of an airstrike, Myanmar Witness geolocated imagery of an older woman, who appears to have suffered injuries to the head, to the nearby IDP camp at 19.668927, 96.891276 (Figure 8). Myanmar Witness also identified images of a child with injuries to their head in this same post, but these images could not be geolocated.

Figure 8: Geolocation of image of a claimed airstrike victim (right) at the IDP camp located at 19.668927, 96.891276. Sentinel Hub imagery (bottom left) was taken from 22 April 2023. [Peakvisor](#) utilised for mountainscape confirmation (top left) (Source: [Khit Thit Media](#)).

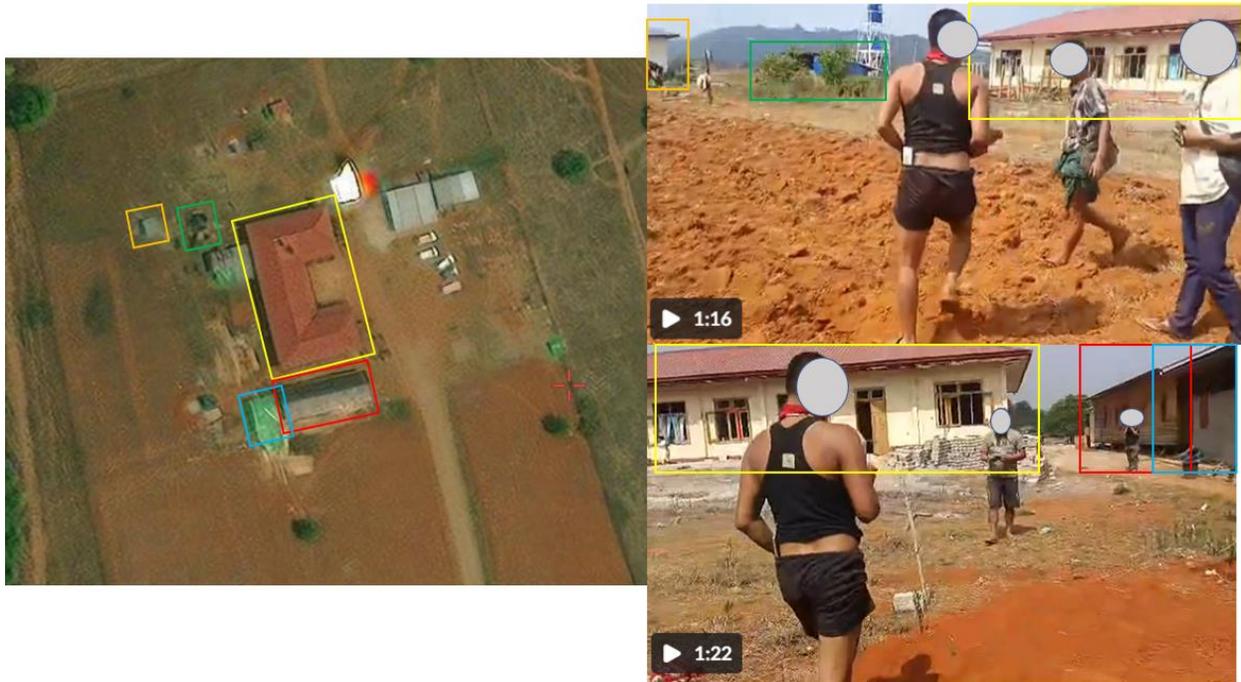
Myanmar Witness has geolocated footage of a shell being dug up out of the ground next to the medical facility at 19.669768, 96.889202 (Figure 9). According to [Radio Free Asia](#), a Moby PDF member stated that a munition did not go off when it landed at the site, leading Myanmar Witness to believe that the shell shown in UGC images from the site (Figures 10a and 11) is the munition mentioned, as it is being dug up unexploded.

Figure 9: Video footage of a munition being dug up next to the hospital (19.669768, 96.889202) (Source: Private).

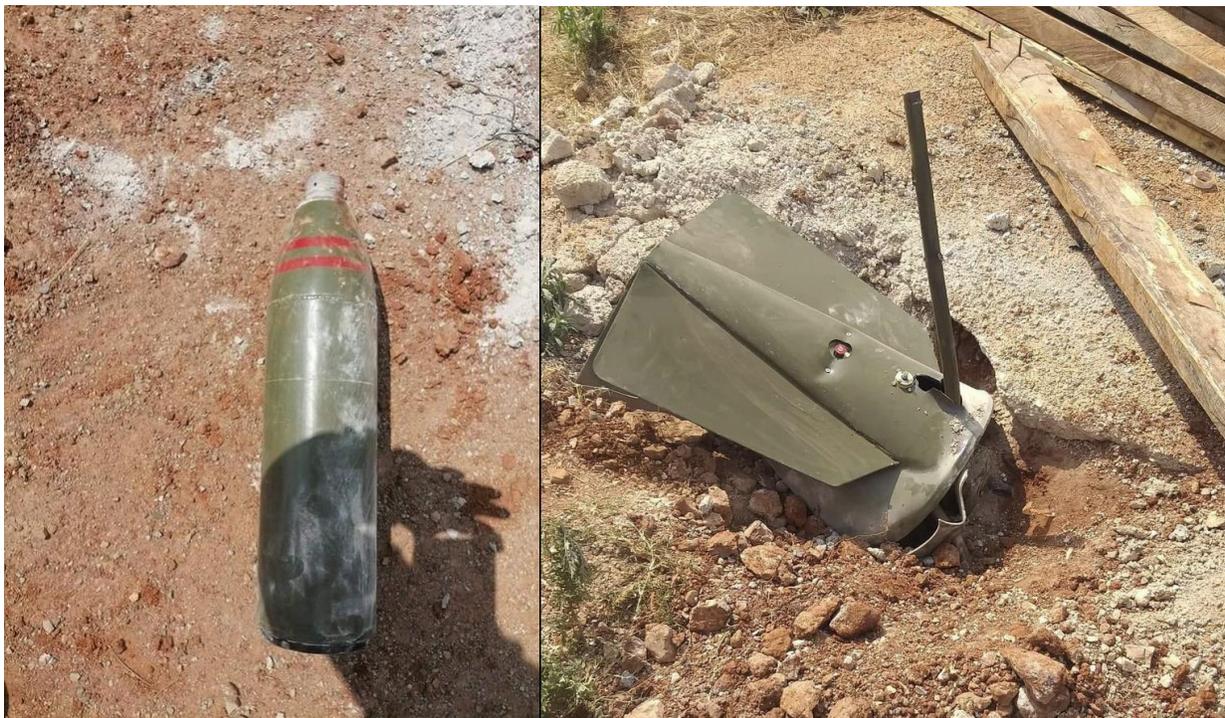
Myanmar Witness is unable at this time to identify the type and calibre of this munition, nor the weapon that uses it. However, Myanmar Witness strongly believes the imagery of the remnant in Figure 10b, allegedly recovered close to the location of the attack, to show part of a large-calibre air-delivered bomb.

Figures 10a and 10b: Munition remnants allegedly found at the site of the damaged medical facility (Source: [Khit Thit Media](#) and [Red Peacock News](#)).

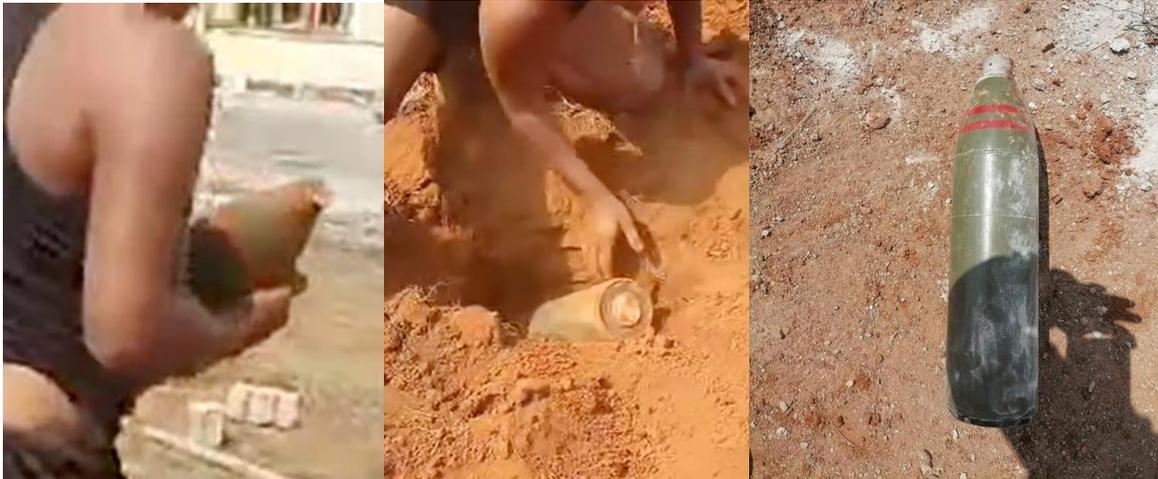
Figure 11: Screenshots taken from the video of munitions being dug up (left and middle), as compared to the clear image of the munitions allegedly found at the site (right). These items look similar enough to likely place the munitions images in the location alleged. (Source: Private).
