Civilian infrastructure and food supplies destroyed in Myanmar military arson attacks

SAC operations in East Tabayin township, Sagaing region

REPORT BY MYANMAR WITNESS, 17 MARCH 2023

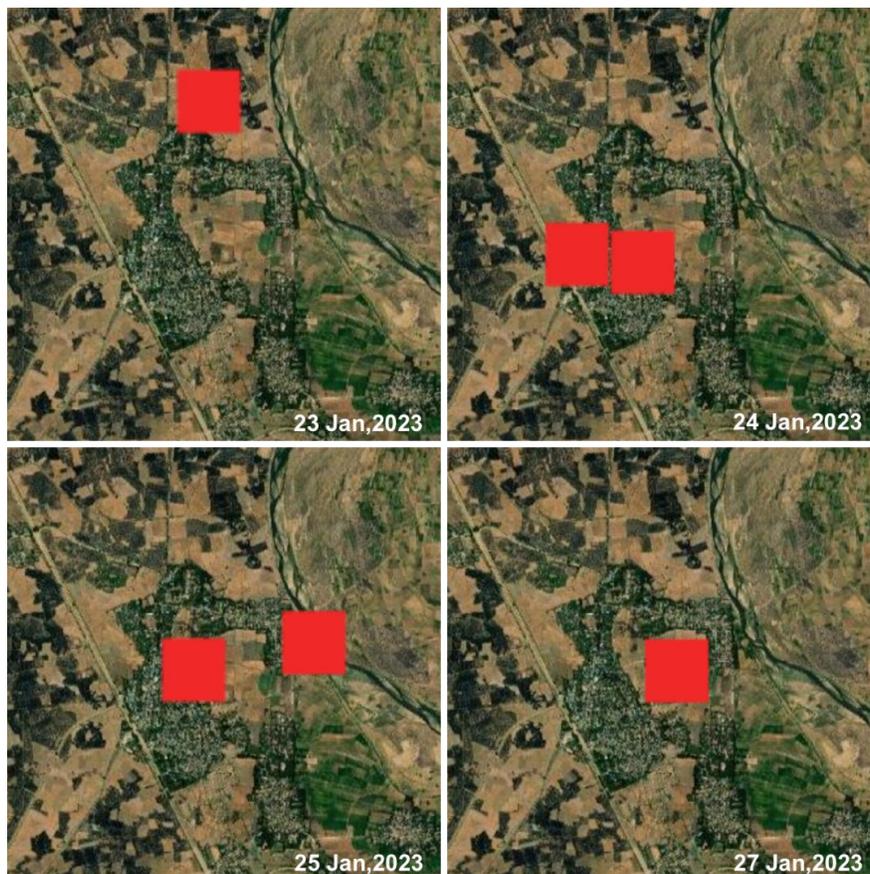
Between 23-27 January 2023, The Fire Information for Resource Management System (FIRMS) shows multiple areas of high heat signatures in Nyang Hla village, consistent with the dates of the reported fires (Figure 2).

Figure 2: FIRMS identified [fire](#) events between 23-27 January 2023

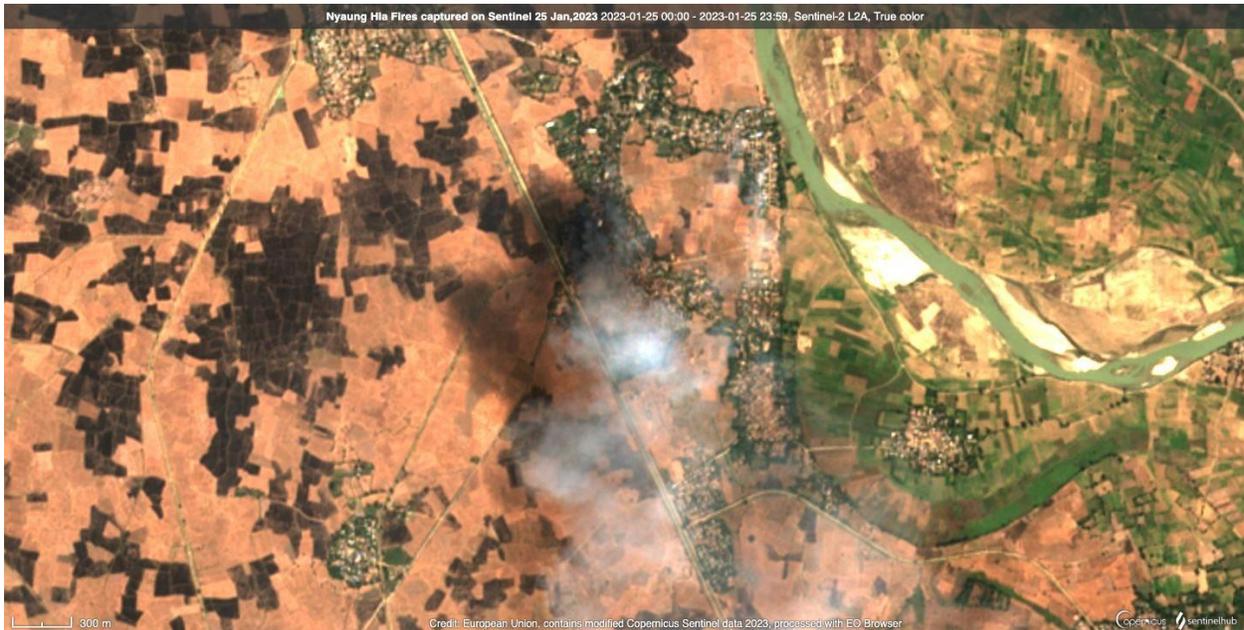
The fire locations identified using FIRMS were further analysed using [Sentinel](#) satellite imagery. Nyaung Hla and Tha Yet Taw were visibly damaged during the investigated timeframe, corroborating the FIRMS data on 25 January 2023. Additionally, an image from Sentinel hub on the 25 January shows smoke above the area (Figure 3). This can be seen by the discoloration shown in Figure 4 (from 10 January 2023 to 30 January 2023).

Figure 3: Sentinel Hub [imagery](#) showing smoke above the area on 25 January 2023

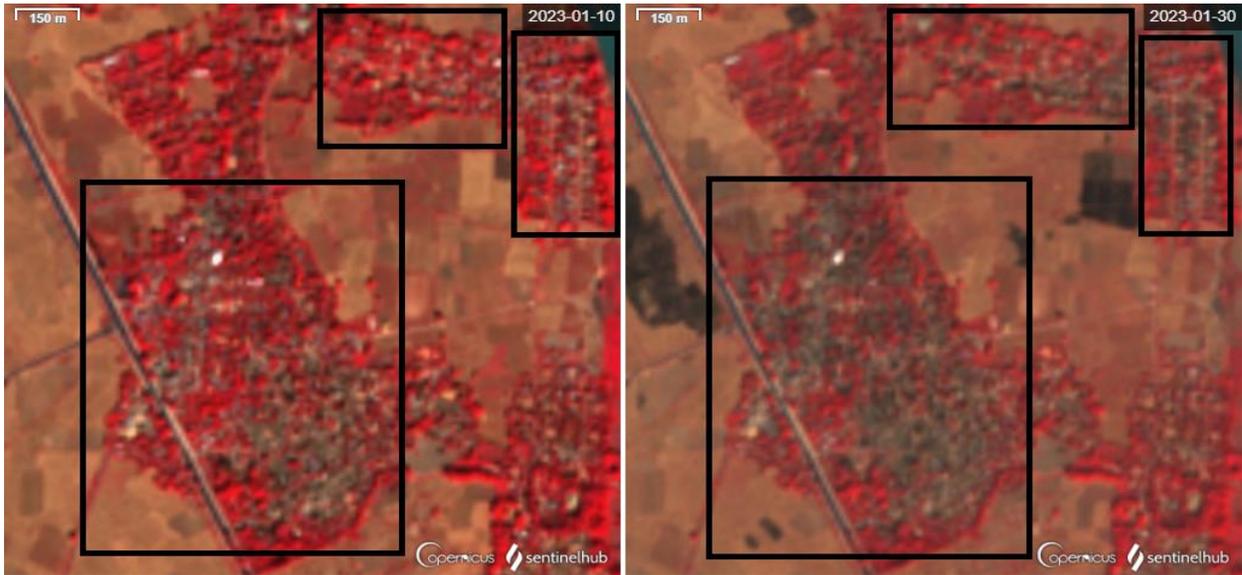
Utilising Sentinel Hub's 'False Colour' filter, as shown in Figure 4, large areas of Nyaung Hla and Tha Yet Taw have become a more homogeneous brown, indicating a loss of vegetation and thus supporting the FIRMS identified presence of various fire events.

Figure 4: False colour satellite [imagery](#) showing the decrease of vegetation in the urban areas in Nyaung Hla Village and Tha Yet Taw Village

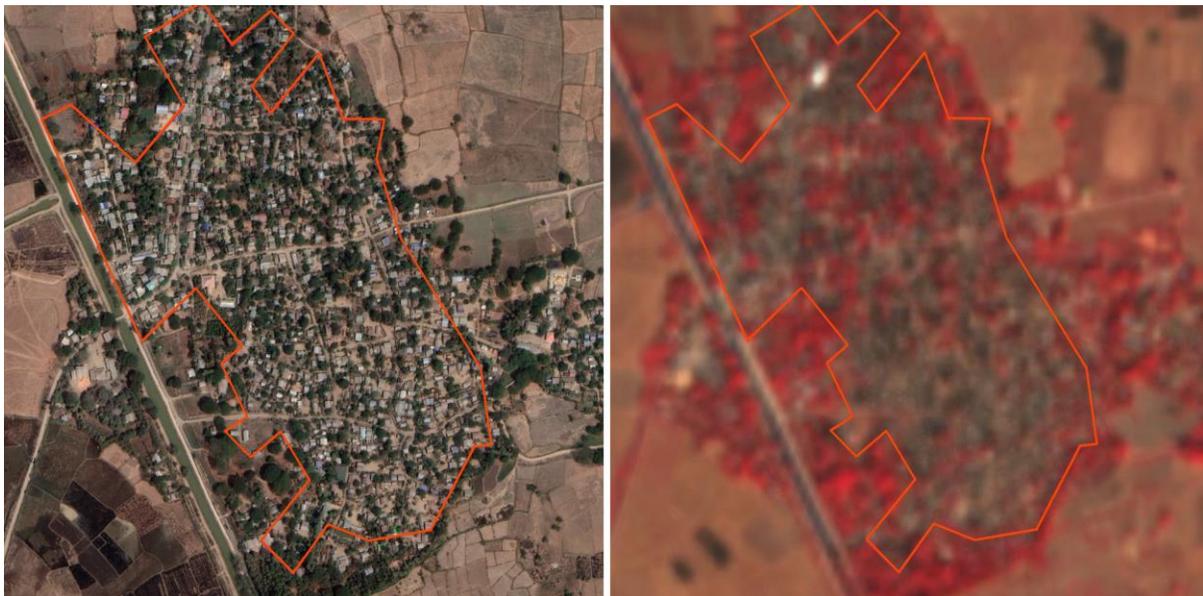
Sentinel imagery can also be used to count and estimate the number of damaged or destroyed houses. This is done by overlaying the discoloured area with higher resolution imagery (Figure 5). Using this method, Myanmar Witness was able to estimate that up to 402 houses were damaged or destroyed.

Figure 5: the outline of the damage seen in sentinel was overlaid onto the higher resolution imager showing Nyaung Hla Village

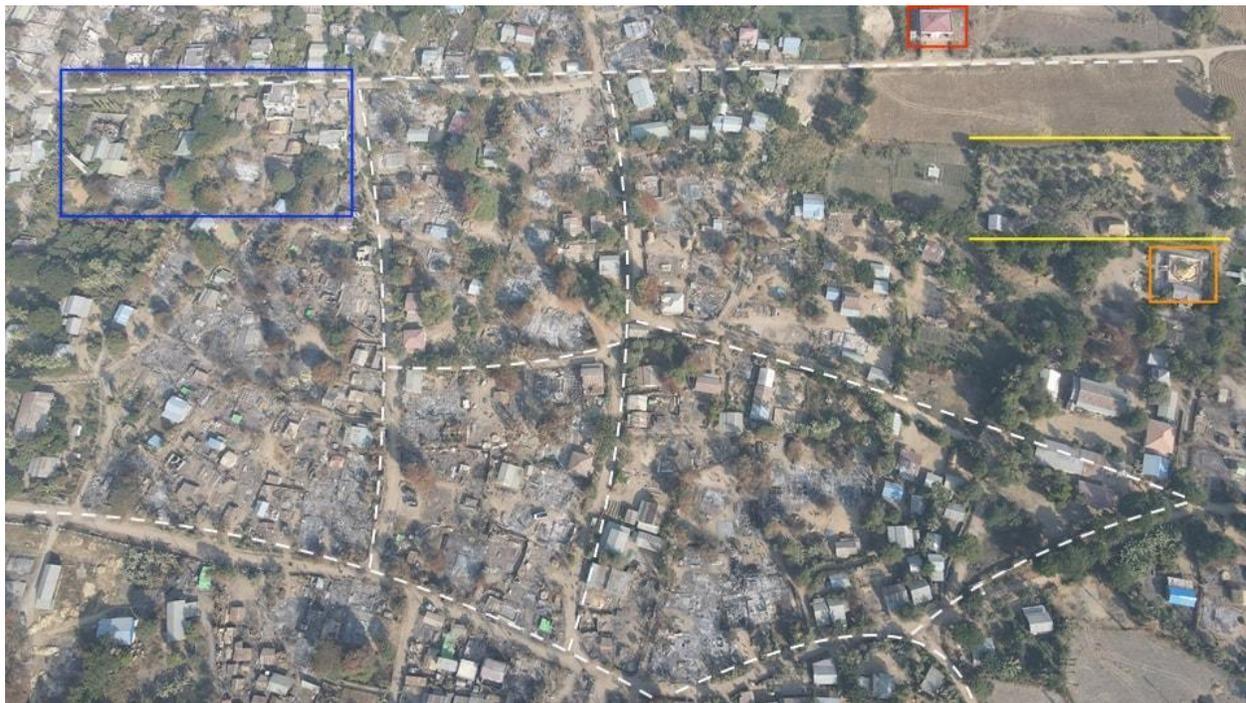
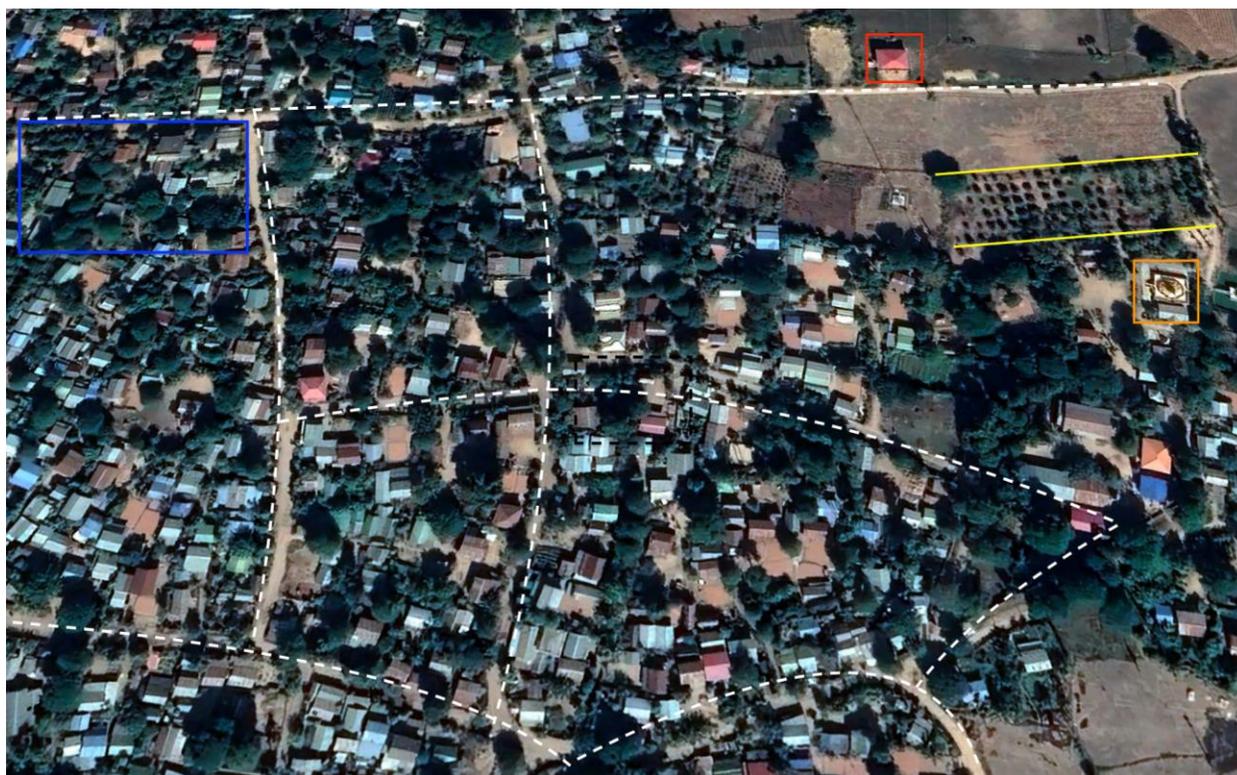
The fires in Nyaung Hla village visibly damaged a rice mill located in the west of the village. Figure 6 and 7 compare drone footage (UGC) and satellite imagery of the location near the rice mill (blue box), showing the damage incurred by the fire.

Figure 6: [Aerial view](#) of Nyaung Hla village taken by a drone after the fires compared to Google Earth Imagery.

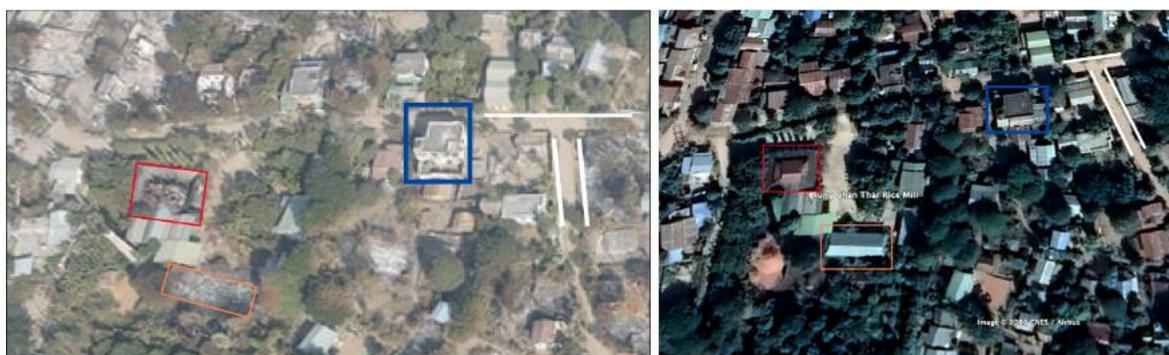
Figure 7: The rice mill in Nyaung Hla (red box) was geolocated using the [UGC footage](#) and satellite image.
[22.655667, 95.416778]

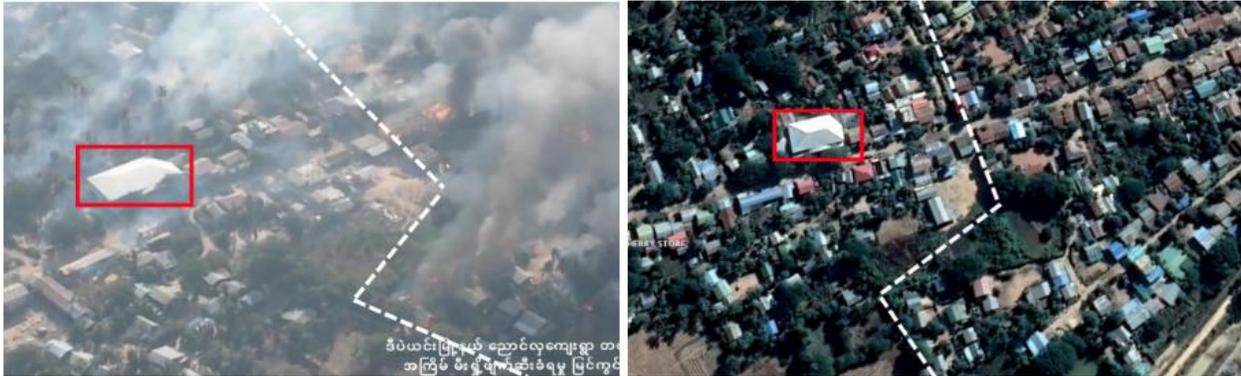
Figure 8 shows the geolocation of the middle section of Nyaung Hla village. The boundary (marked by the dotted line) and the white roofed house (marked in a red box) are verified by matching UGC with satellite imagery. The [post](#) claims the events took place on 24 and 25 January 2023, corroborating the aforementioned FIRMS and Sentinel data.

Figure 8: Image on the left shows the snapshot from the source [video](#) of the burning village and was located using the roofs and roads to [22.658455, 95.416979] (Nyaung Hla village).

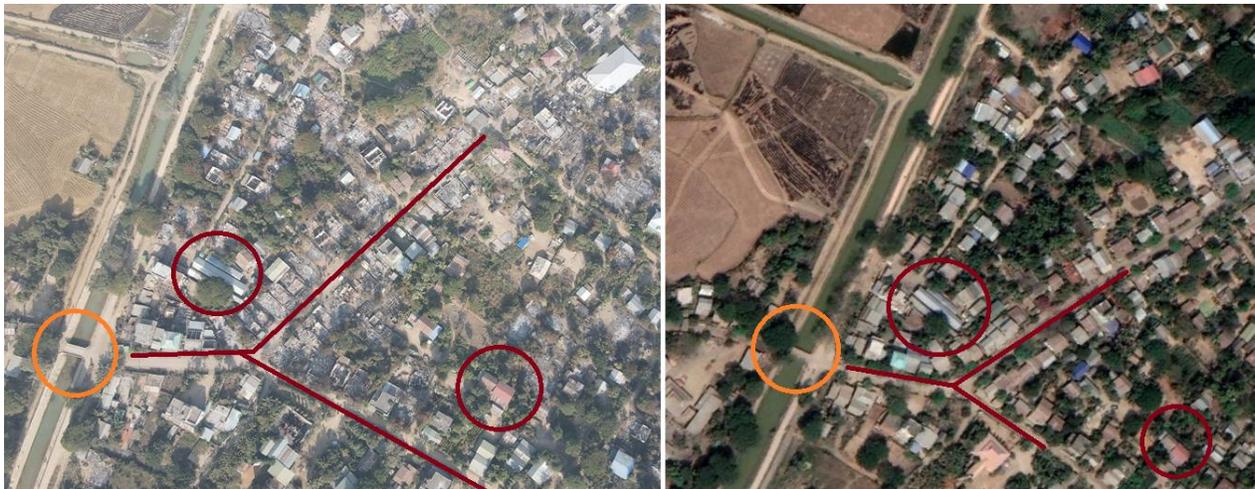
Figure 9 shows the geolocation of an area in the west of Nyaung Hla village near the canal. The road (marked in red) and the bridge (marked in orange) are verified with the matching satellite imagery.

Figure 9: Image on the left is a snapshot of a [video](#) and is geolocated using the bridge, water, roofs and roads [22.655851, 95.416388].

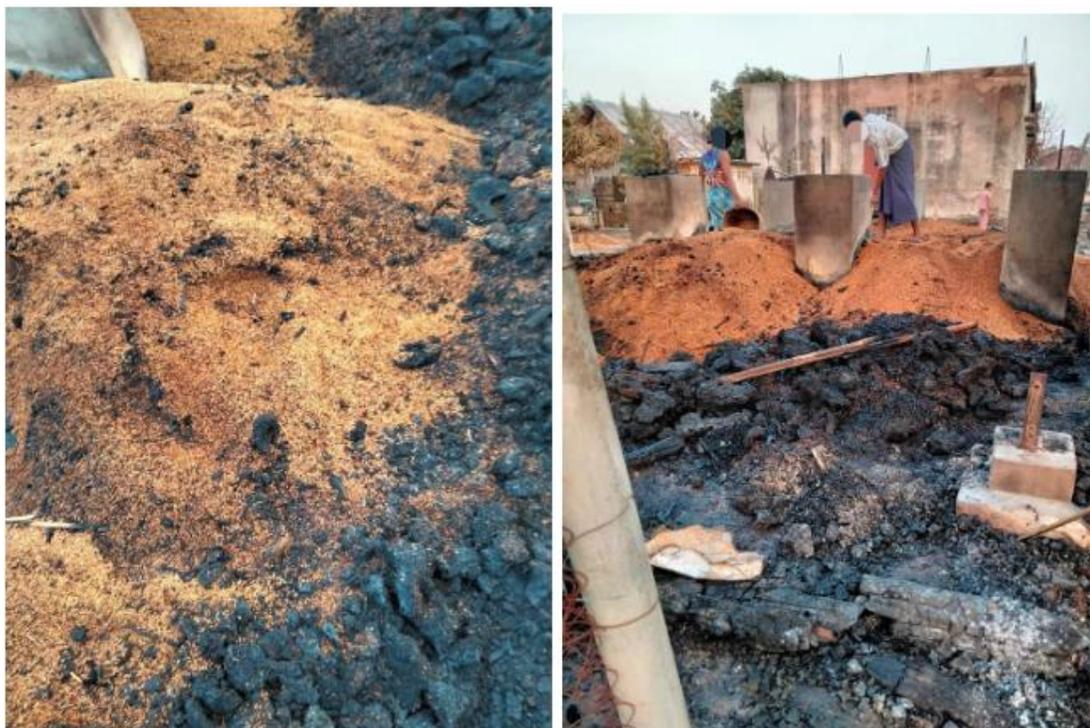
In Ma Ya Kan village, SAC troops [allegedly](#) burned the rice storage building (Figure 11) and damaged an estimated 70 houses. Myanmar Witness was able to verify the fire in the village using Sentinel satellite imagery, but the footage posted online of the burnt rice does not provide enough information to verify its location through geolocation.

Figure 11: [Footage](#) of the partially burnt rice paddy mixed with burnt building remnants.

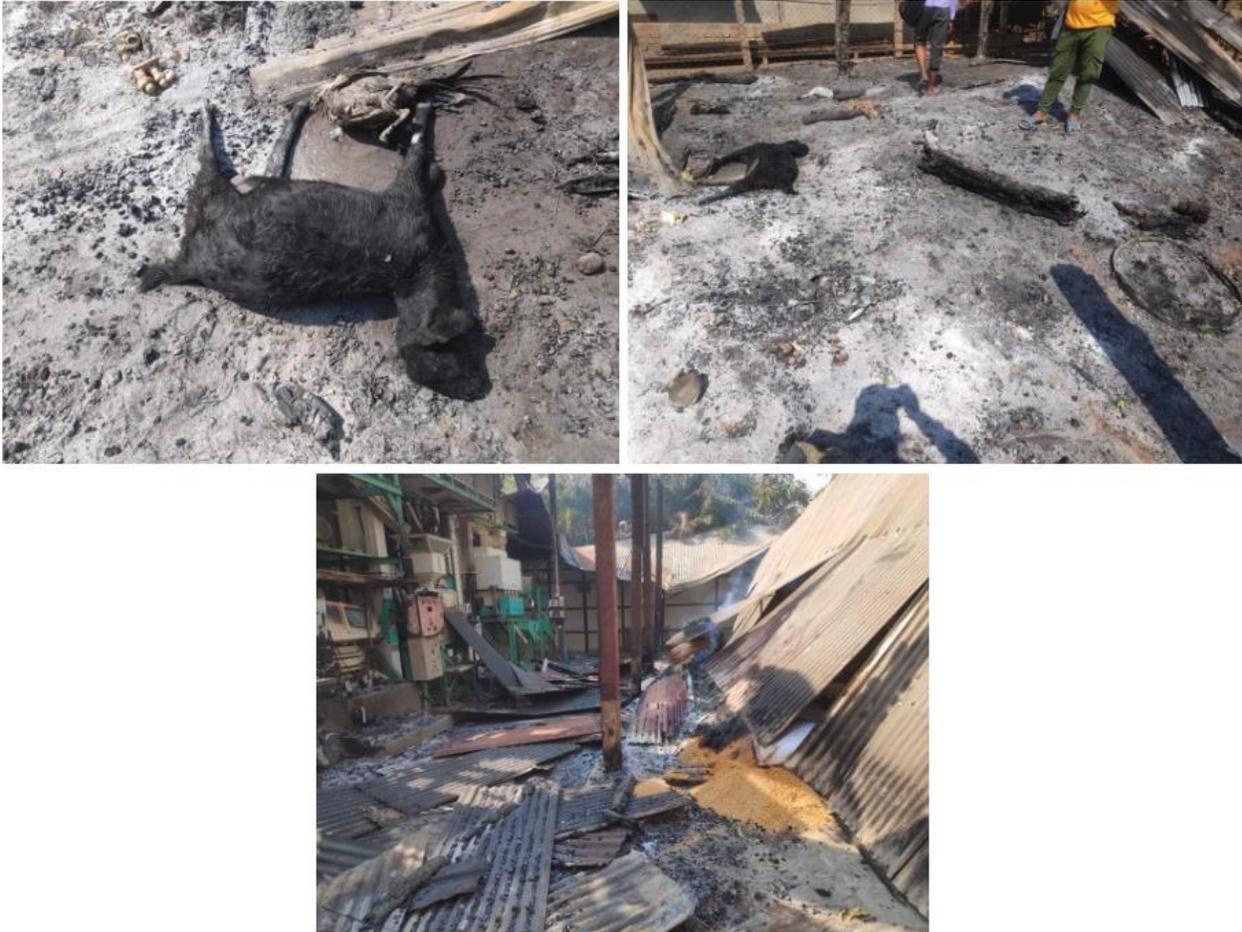
Photos allegedly taken in Nyaung Hla village also show the destruction of food supplies. At least four farm animals were reported to have died as a result of the fires, and a partially burnt rice storage building can be seen (Figure 12).

Figure 12: (Top left) [Dead farm animals](#), one hen and possibly one goat. (Top right) Same two farm animals [along with](#) two other animals on the ground. (Bottom) Rice paddy seen [burnt](#) under the rubble. All photos were [reportedly](#) taken in Nyaung Hla village.

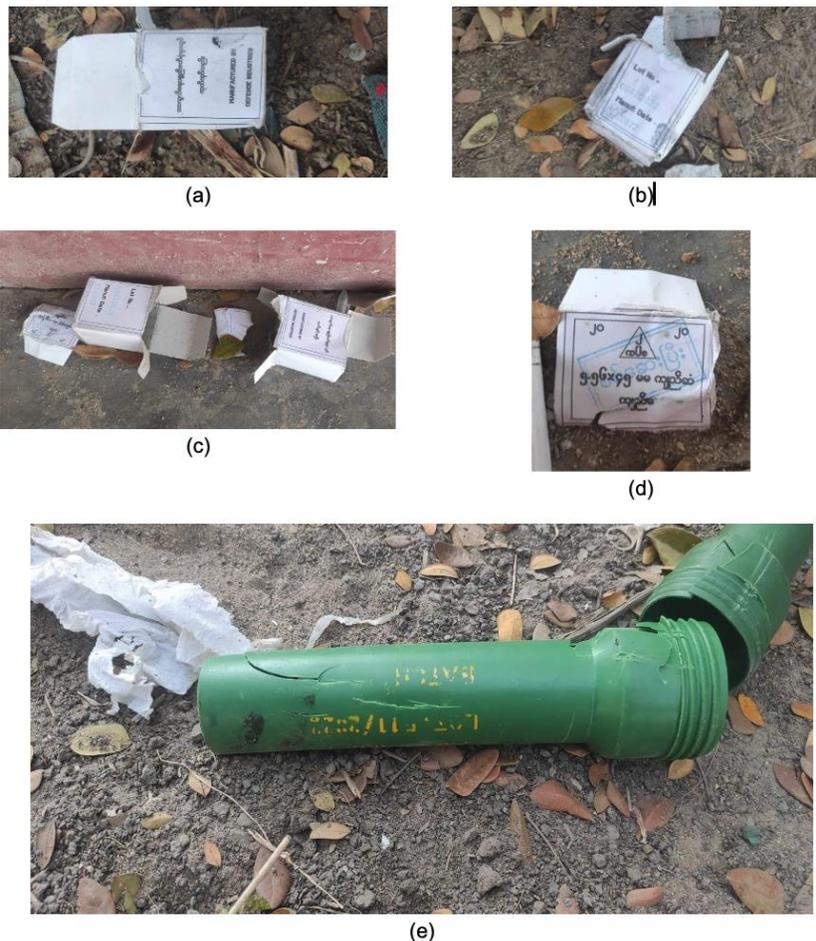
Figure 13: Top to bottom (a) Ammunition case with the label that reads, “Manufactured by Defence Industries” in both Burmese and English. (b) Ammunition case that reads, “Lot No and Manufacture Date”. (c) Multiple ammunition

cases. (d) Ammunition case that reads, “KaPaSa (2) 5.56x45mm bullets”. (e) has matching features to a container tube for 40mm rifle grenade model MG-2, manufactured by DDI (Source: [Khit Thit Media](#)).

Several used packages of bullets (Figure 13 a-d) labelled Ka Pa Sa, Defence Industries (ကကွယ်ရေးပစ္စည်းစက်ရုံ, ကပစ), were allegedly found in Nyaung Hla village. The box in Figure 12a states “Manufactured by Defence Industries”. Figure 12d shows a paper box labelled “KaPaSa (2) 5.56x45mm bullets”, and Figure 12e shows possible rifle grenade casings - the features match the container tube for a 40mm rifle grenade model MG-2 which is used by the Myanmar military. This is determined due to the tube size and cracking of the tube body with the twist off end. While Myanmar Witness cannot verify the location where these boxes and weapons were found, the weapon characteristics and manufacturers signal that they belonged to SAC troops.
